Property Address SAMPLE INSPECTION

Type Ownership: (unknown, no documentation supplied) Informational Note: (Not verified)
REPAIR RECOMMENDATION when the inspector calls for a licensed contractor to evaluate and make repairs to a certain item or area, the contractor should evaluate the complete system or area for any additional repairs. The contractor should report to the buyer the cost of the repairs and the condition and function of the system before closing. For the protection of the buyer, if the home owner does the repairs, the buyer should have a licensed contractor inspect the work before closing for condition and quality of work.
Additions/Modifications SAMLPE REPORT - G WARREN INC HOME INSPECTION

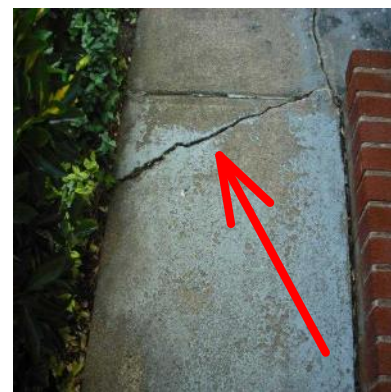
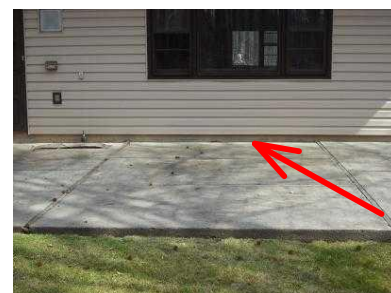
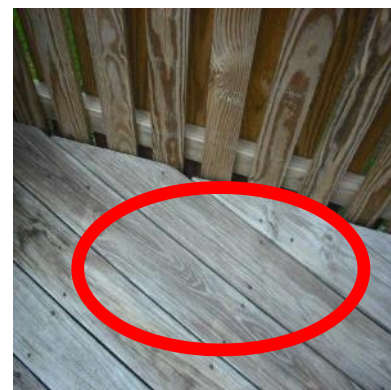
3. **Repair Walks:** (Standard concrete slabs) Sidewalk damaged, repair as necessary
4. **Appears Serviceable Front Exterior Stairs:** (Brick and concrete) General maintenance require, maintain and repair when necessary

5. **Appears Serviceable Rear/exterior/stairs:** (Wooden steps) Wooden steps, general maintenance required
6. **Repair Patio:** (Concrete) Negative slope - towards foundation, which brings rain water towards the foundation instead of away from the foundation (the patio appears to be sunk a couple of inched, repair as necessary)

7. **Repair Deck:** (Wooden deck) general normal maintenance required, decks are susceptible to all weather conditions, regular routine maintenance required to assure safe functional condition (Note - there are a few loose boards and the deck needs sealer treatment, repair as necessary)

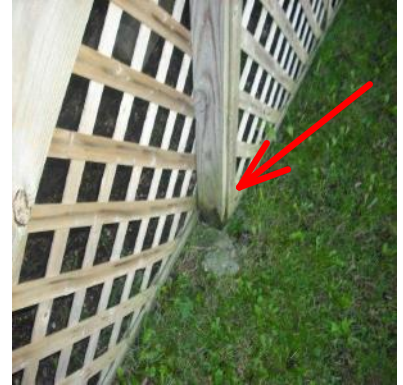
8. Repair **Deck:** (Wooden deck) Support posts - are not set on concrete, the posts are wood to ground contact which rots wood and attracts termites

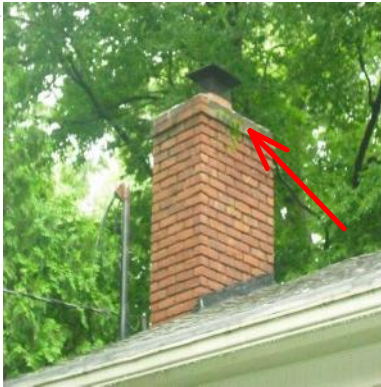
| (Mid section of house roof) Chimney | | |

| 14. Repair | <p>Chimney: (Brick and mortar) General pointing maintenance of chimney and flashing is required to avoid water problems. Damaged noted, repair as necessary</p> | |

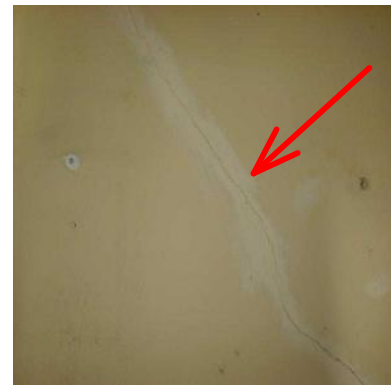
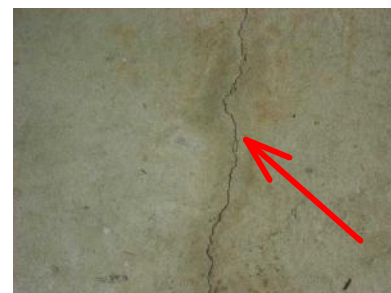
12. **Marginal Floor/Foundation:** (concrete floor) Crack in floor noted , repair as necessary
13. **Appears Serviceable Electrical:** (Standard/3 prong outlets)

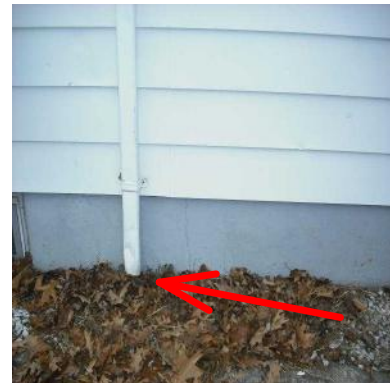
Gutters/Downspouts: (Same as house) Downspouts - extensions needed to direct water at least four feet away from the foundation

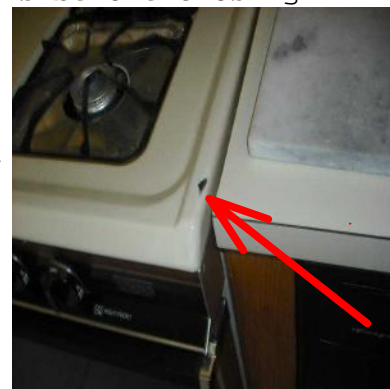
Stove/oven: (Standard stove/oven) Chip in stove burner area noted, repair as necessary, Also Noted, Door spring broken - The oven door spring appears to be broken, this is considered a safety hazard

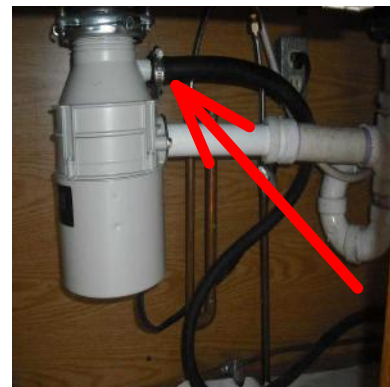
Dishwasher Discharge: (Improper discharge) Discharge line goes to drain from point lower than the drain, it should go to the drain from a point higher than the drain (commonly called the high loop method, usually the line is secured to the underside of the counter top)

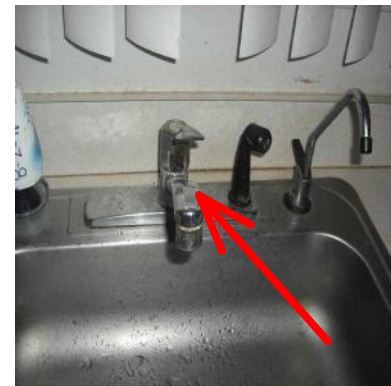
- 8. Appears Serviceable Sink: (Standard sink)
- 9. Appears Serviceable Electrical: (Standard/GFIC)
- 10. Appears Serviceable Kitchen Lights: (Standard lights)
- 11. Repair Plumbing/Fixtures: (Standard faucet/plumbing)
Faucet is leaking, repair as necessary

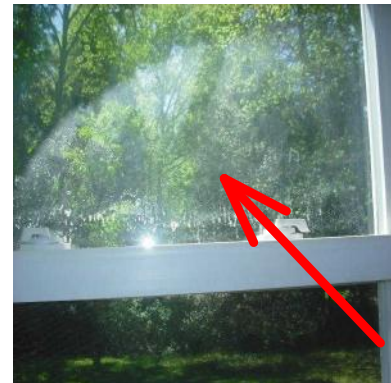
Windows: thermopane General maintenance required, caulk, seal, free up and maintain and repair when necessary, Thermopane window damage noted in one or more thermopane windows there is moisture between the layers of glass, A qualified glazier is recommended to evaluate all windows and estimate repairs before closing

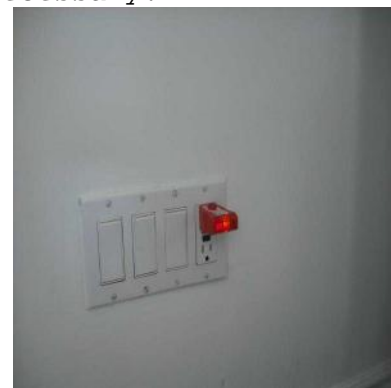
Electrical: Electrical wiring) outlets - non grounded outlets noted, recommend evaluation and repair by licensed electrician before closing

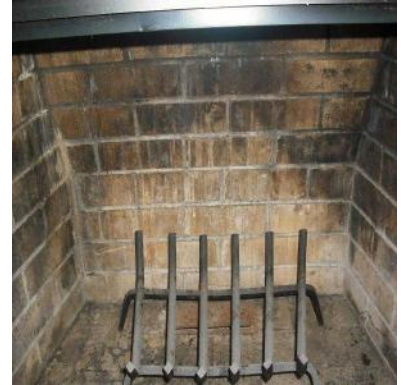
Firebox: (Standard firebrick) clean fireplace/flue - recommend cleaning the fireplace and flue and damper before using

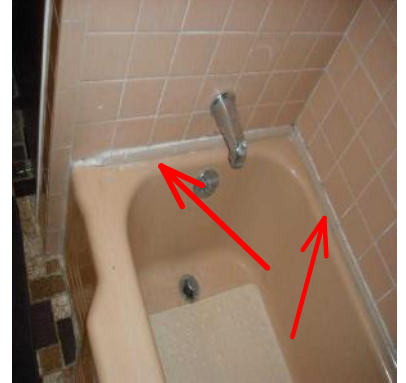
Tub/Surround: (Tub/ceramic tile surround)
Caulking maintenance - replace caulking and sealer at tub surround to avoid water penetration behind the tiles

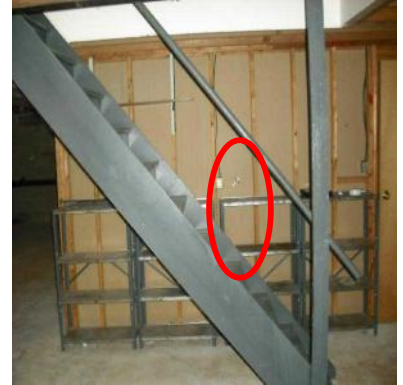
Basement Stairs/Railings: (Stairs/hand rail)
Open space on side of basement stairs is a safety hazard, A person or child could fall off the stairs to basement floor, recommend some type of safety balusters be installed.

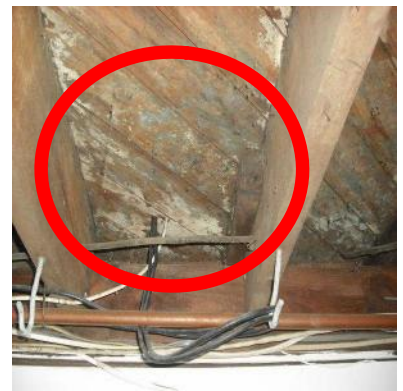
Informational Note: (Basement) Mold like substance noted, recommend a mold test before closing NOTE - mold is not included in a home inspection, any comments about mold like substance is courtesy only to protect the buyer, no liability will be accepted.

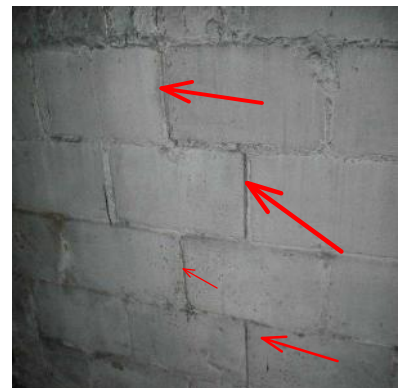
Foundation: (Concrete block/Slab floor)
Cracks noted - cracks noted on foundation concrete block walls, repair as necessary, Recommend evaluation and repair by a licensed contractor before closing

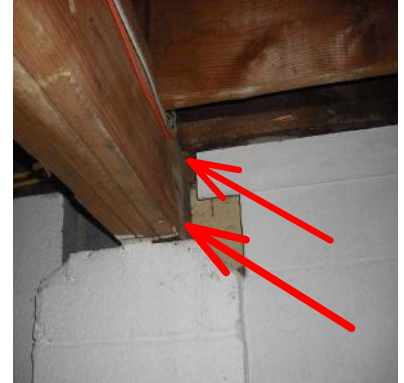
Beams: (Solid wood) some termite damage noted, see termite report)

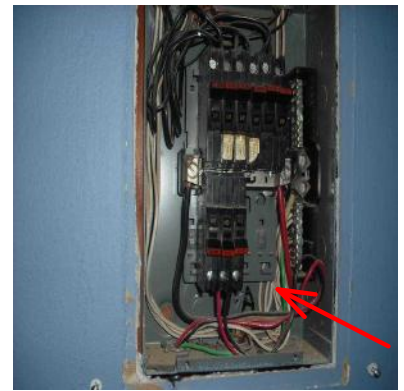
9. Repair **Manufacturer:** (Federal Pacific) Federal Pacific panel - breakers have a history of not tripping when circuit overloading exists, Evaluation of the panel box and wiring system by a licensed electrician is recommended before closing

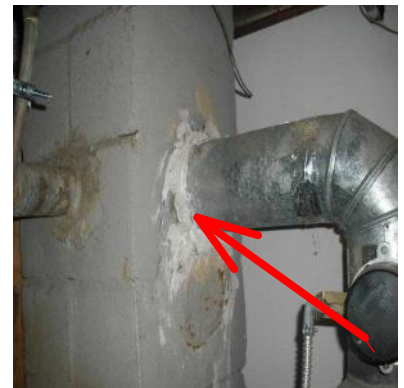
13. Safety Issue **Flue Pipe:** (Metal flue pipe) Sealer maintenance needed where flue pipe goes into chimney

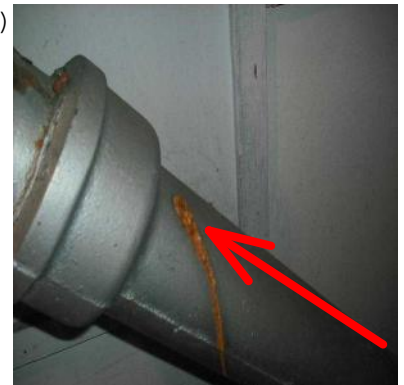
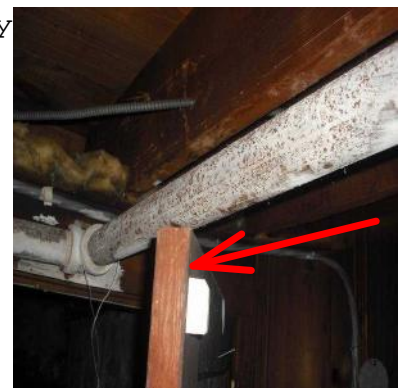
6. **Repair** **Drain Pipes:** (Drain pipe) pipe is supported by board, should have pipe hanger, repair as necessary
7. **Appears Serviceable** **Vent Pipes:** (Standard/Drain/Vent line, note - no liability will be accepted for pipes that develop leaks after the inspection or leaks that are hidden from view)) limited view of drain and vent lines, due to finished walls, ceilings and other areas, no responsibility will be accepted for any plumbing lines of any type that are not visible

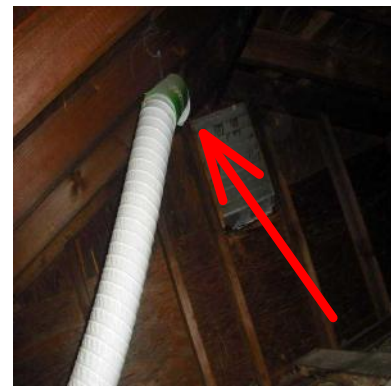
11. Information Note Fan/house: (Not applicable)
12. Repair Bathroom Fan Venting: (Improper vent discharge) Fan vent terminates in the attic, this is an environmental safety hazard, repair as necessary

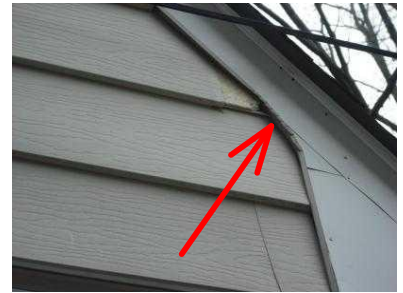
5. Trim/Fascia: (Wood) General maintenance required, maintain and repair when necessary, some wood rot noted, repair as necessary

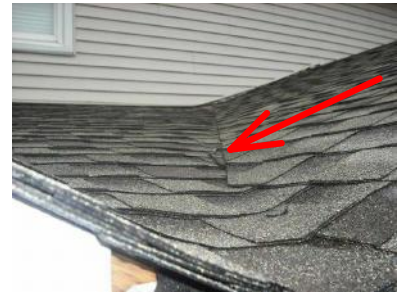
6. (Main roof) Roof Surface Material: (Asphalt Shingles) Shingles, deterioration/damage noted at the valley, Recommend evaluation and repairs by licensed contractor before closing
7. Valleys: (Asphalt shingle) Valley shingles damaged, roof leak noted in this area, repair as necessary, recommend evaluation and repair by licensed contractor before closing

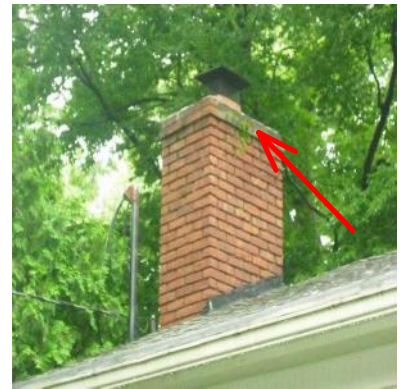
8. (Mid section of house roof) Chimney Chimney: (Brick and mortar) General pointing maintenance of chimney and flashing is required to avoid water problems. Damaged noted, repair as necessary

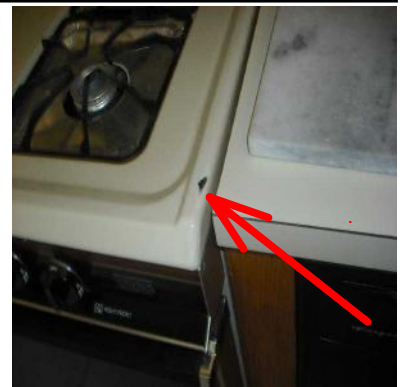
10. (First floor) Kitchen Stove/oven: (Standard stove/oven) Chip in stove burner area noted, repair as necessary, Also Noted, Door spring broken - The oven door spring appears to be broken, this is considered a safety hazard

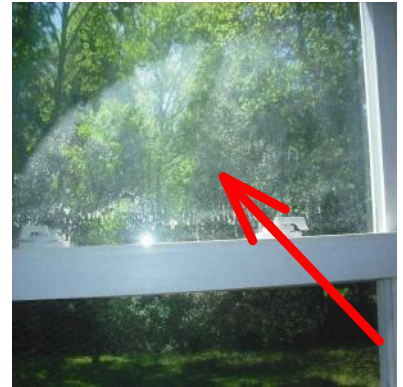
12. all rooms except kitchen and bathrooms Living Space Windows: thermopane General maintenance required, caulk, seal, free up and maintain and repair when necessary, Thermopane window damage noted in one or more thermopane windows there is moisture between the layers of glass, A qualified glazier is recommended to evaluate all windows and estimate repairs before closing
