Property Information

Property Address SAMPLE INSPECTION

Inspector's Name/License G WARREN INC - FOUR INSPECTORS
Company Name G.Warren, Inc. Home Inspection
Company Address 51 Munsee Drive
City Cranford State NJ Zip 07016
Inspection Comp. Phone 908-757-3400 Fax 908-753-1711
Company location Address AREA LOCATION - Cranford New Jersey
E-Mail gwarreninc@aol.com
File Number NJ-1000
Amount Received As per contract

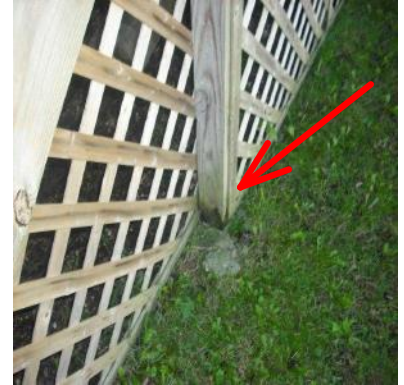
9. Repair

Deck: (Wooden deck) Support posts - are not set on concrete, the posts are wood to ground contact which rots wood and attracts termites

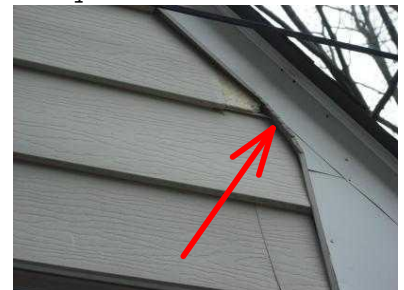
3. Repair

Trim/Fascia: (Wood) General maintenance required, maintain and repair when necessary, some wood rot noted, repair as necessary

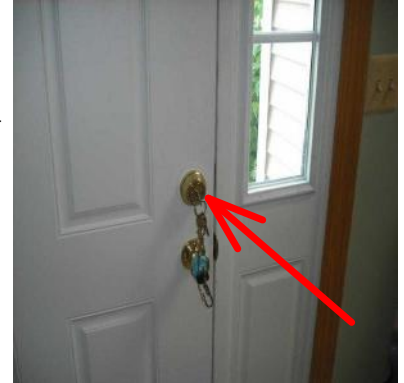
8. Safety Issue Front door entry: (Exterior door, Conventional) keyed dead bolt on the interior side of the door is a real safety hazard. In the event of a fire the door may be locked and the key cannot be found. Recommend removal of this type lock before closing

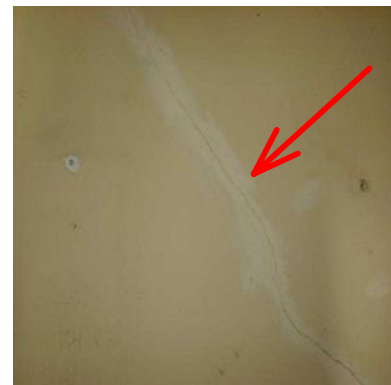
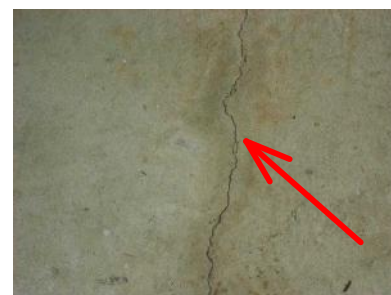
13. **Marginal Floor/Foundation:** (concrete floor) Crack in floor noted , repair as necessary
14. **Appears Serviceable Electrical:** (Standard/3 prong outlets)

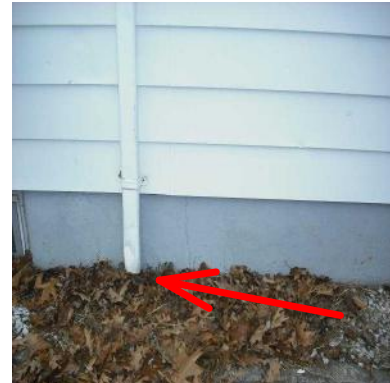
15. Marginal

Gutters/Downspouts: (Same as house) Downspouts - extensions needed to direct water at least four feet away from the foundation

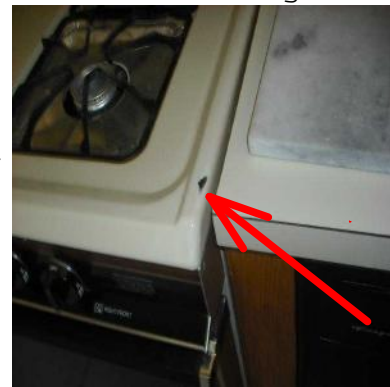
2. Repair

Stove/oven: (Standard stove/oven) Chip in stove burner area noted, repair as necessary, Also Noted, Door spring broken - The oven door spring appears to be broken, this is considered a safety hazard

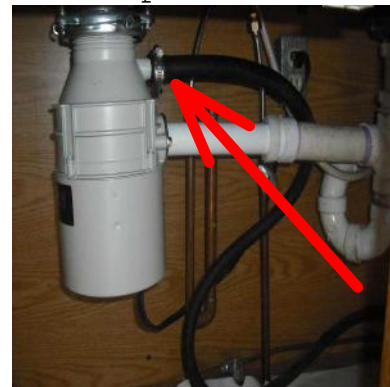
Dishwasher Discharge: (Improper discharge) Discharge line goes to drain from point lower than the drain, it should go to the drain from a point higher than the drain (commonly called the high loop method, usually the line is secured to the underside of the counter top)

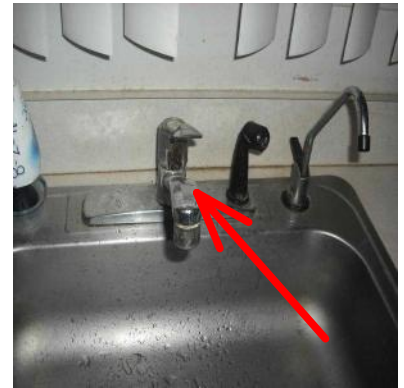
- 8. Appears Serviceable Sink: (Stainless Steel)
- 9. Appears Serviceable Electrical: (Standard/GFIC)
- 10. Appears Serviceable Kitchen Lights: (Standard lights)
- 11. Repair Plumbing/Fixtures: (Standard faucet/plumbing)
Faucet is leaking, repair as necessary

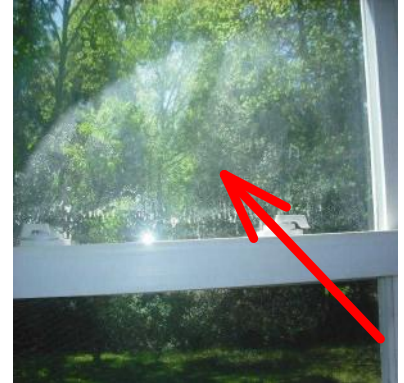
6. Repair

Windows: thermopane General maintenance required, caulk, seal, free up and maintain and repair when necessary, Thermopane window damage noted in one or more thermopane windows there is moisture between the layers of glass, A qualified glazier is recommended to evaluate all windows and estimate repairs before closing

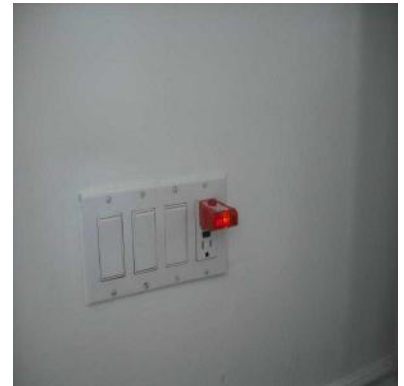
9. Repair

Electrical: (Electrical wiring) outlets - non grounded outlets noted, recommend evaluation and repair by licensed electrician before closing

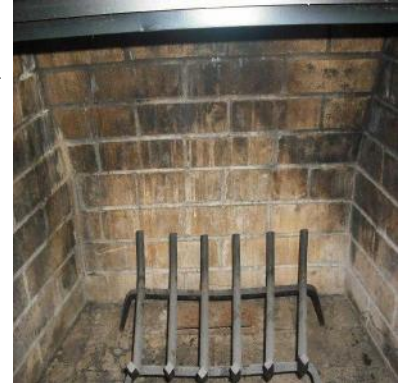
Firebox: (Standard firebrick) clean fireplace/flue - recommend cleaning the fireplace and flue and damper before using

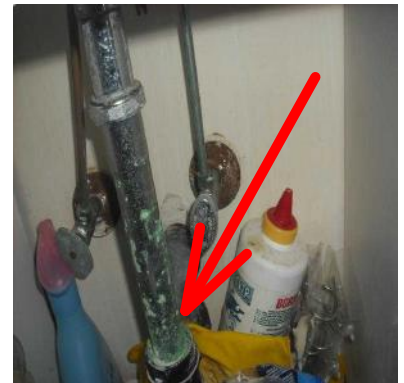
6. Repair **Faucets/Traps:** (Standard faucets/plumbing) Drain line corrosion noted, repair as necessary

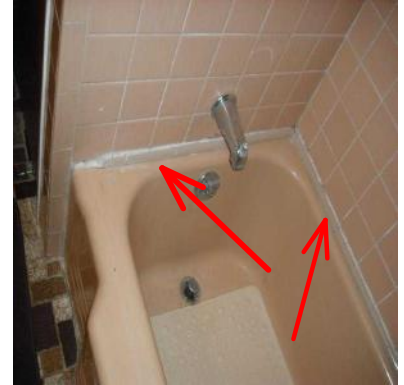
7. Marginal

Tub/Surround: (Tub/ceramic tile surround)
Caulking maintenance - replace caulking and sealer at tub surround to avoid water penetration behind the tiles

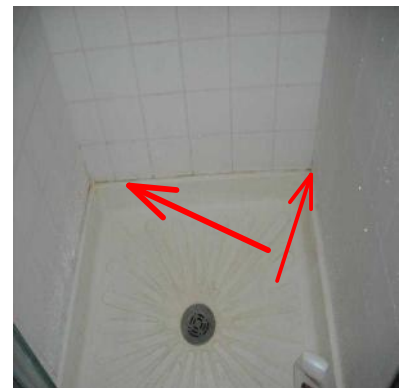
Shower/Surround: (Pan/ceramic tile surround)
Normal caulking sealer maintenance required on walls and floor pan to avoid leaks and wall damage. No liability will be accepted for any hidden wall damage that may develop behind finished surfaces.

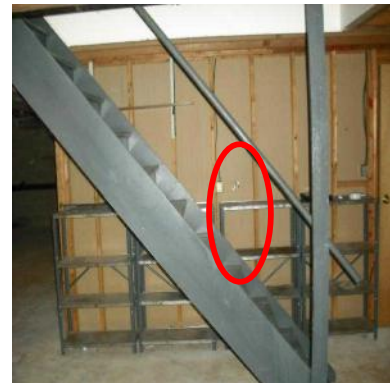
Basement Stairs/Railings: (Stairs/hand rail)
Open space on side of basement stairs is a safety hazard, A person or child could fall off the stairs to basement floor, recommend some type of safety balusters be installed.

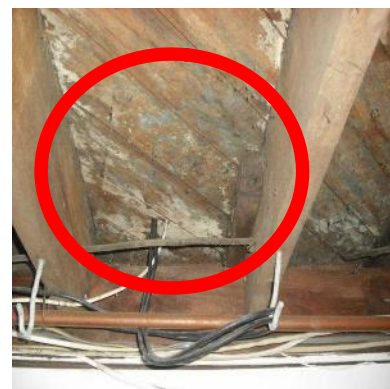
14. Repair

Informational Note: (Basement) Mold like substance noted, recommend a mold test before closing NOTE - mold is not included in a home inspection, any comments about mold like substance is courtesy only to protect the buyer, no liability will be accepted.

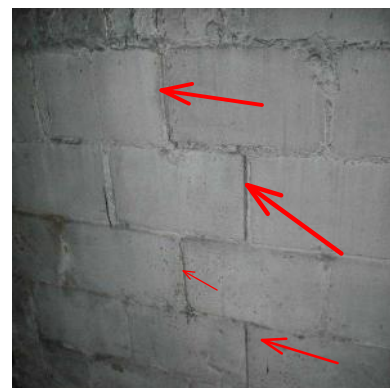
3. **Repair Foundation:** (Concrete block/Slab floor)
Cracks noted - cracks noted on foundation concrete block walls, repair as necessary, Recommend evaluation and repair by a licensed contractor before closing

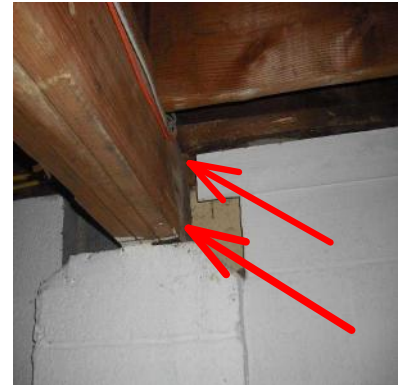
4. Repair Beams: (Solid wood) some termite damage noted, see termite report)

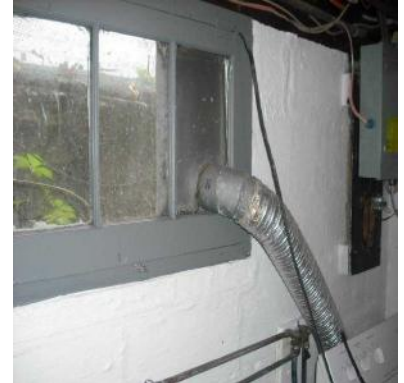
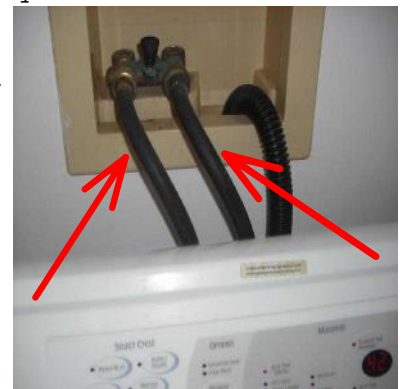
8. **Marginal** **Washer Hoses:** (Rubber Hoses) Rubber hoses noted, recommend update of hoses to metal braided hoses for safety, Over time rubber hoses have been known to leak and cause water damage, metal braided hoses appear to be more reliable.

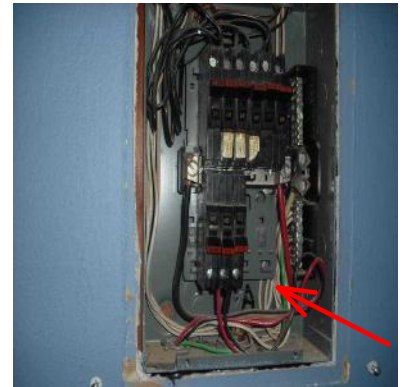
9. Repair **Manufacturer:** (Federal Pacific) Federal Pacific panel - breakers have a history of not tripping when circuit overloading exists, Evaluation of the panel box and wiring system by a licensed electrician is recommended before closing

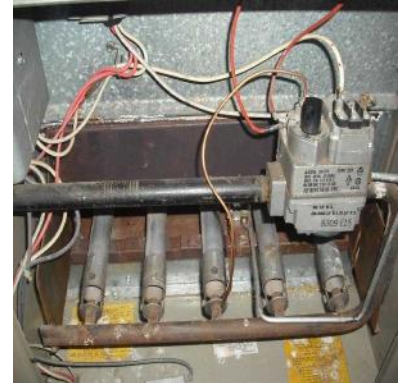
2. Repair

Heating System Operation: (Functional needs service/maintenance) Dirt and rust in the burn chamber and unusual flame pattern, it appears that the unit has not been serviced in the last year as per manufactures service requirements. recommend evaluation and repair by licensed contractor before closing

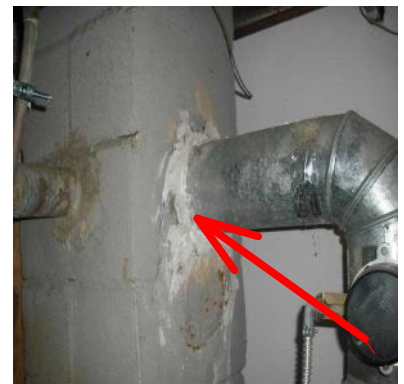
13. Safety Issue **Flue Pipe:** (Metal flue pipe) Sealer maintenance needed where flue pipe goes into chimney

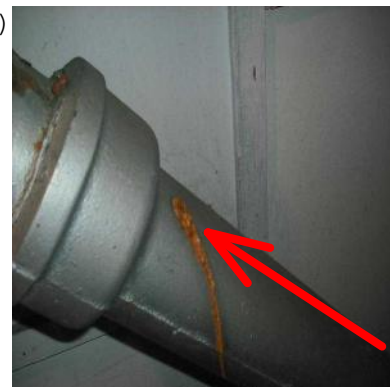
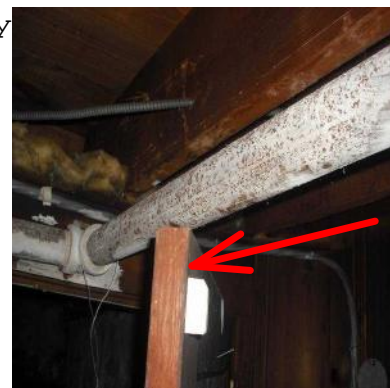
6. **Repair** **Drain Pipes:** (Drain pipe) pipe is supported by board, should have pipe hanger, repair as necessary
7. **Appears Serviceable** **Vent Pipes:** (Standard/Drain/Vent line, note - no liability will be accepted for pipes that develop leaks after the inspection or leaks that are hidden from view)) limited view of drain and vent lines, due to finished walls, ceilings and other areas, no responsibility will be accepted for any plumbing lines of any type that are not visible

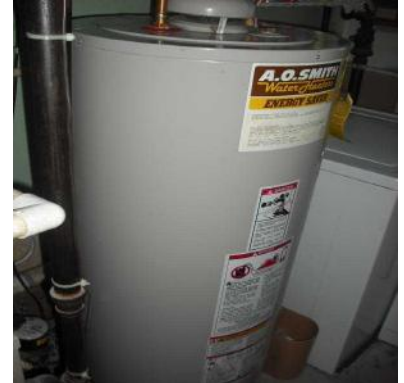
Water Heater Operation: Functional at time of inspection Functional, nearing the end of useful life, manufactures estimated useful life of heater is 10 to 12 years. The heater will need replacement in the near future. (The heater is 15 years old)

10. Manufacturer: A.O. Smith

11. Type: Natural gas Capacity: 40 Gal.

12. **Estimated Age:** 15 plus years estimated, this appears to be past the manufactures estimated useful life, Recommend evaluation by a licensed contractor for date search and condition before closing **Area Served:** Complete dwelling

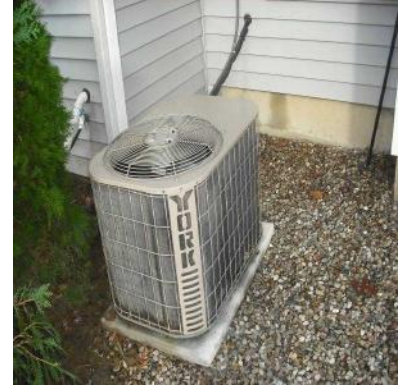
- 4. Unable To Inspect: (All a/c components that are not visible or accessible)
- 5. Manufacture: York Estimated age: 8 years ,estimated age

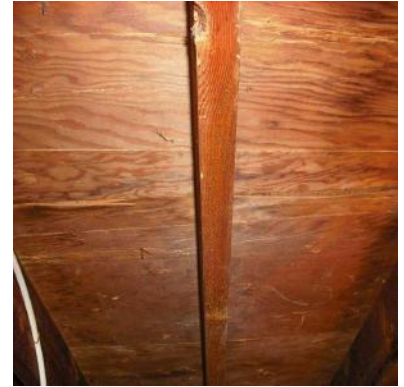
1. **Informational Note:** The attic inspection is a limited visible inspection only, and conducted under the guidelines of the American Society of Home Inspectors and restrictions set forth in the Information and Disclaimer section of this report,
2. **Attic Inspection Method:** (Attic entered, limited view from center floored section)
3. **Appears Serviceable Framing/roof:** (Standard Truss framing)
4. **Appears Serviceable Sheathing:** (standard sheathing) Appears serviceable

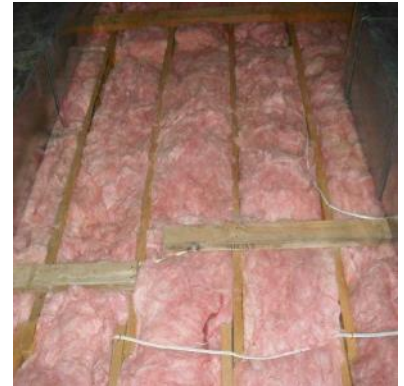
5. **Appears Serviceable Ventilation:** (gable/soffit vents)
6. **Appears Serviceable Insulation:** (Batts) Appears serviceable

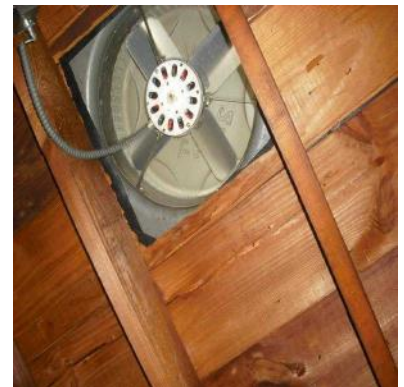
7. **Appears Serviceable Depth/insulation:** (Undetermined)
8. **Appears Serviceable Vapor Barrier:** (Insulation vapor barrier)
9. **Appears Serviceable Fan/attic:** (Roof mounted vent fan) Fan is functional - the roof mounted fan was running and functional and running at the time of inspection

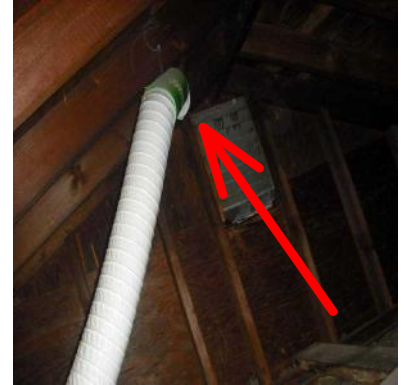
Bathroom Fan Venting: (Improper vent discharge) Fan vent terminates in the attic, this is an environmental safety hazard, repair as necessary

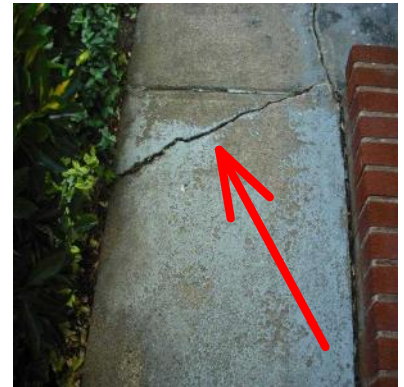
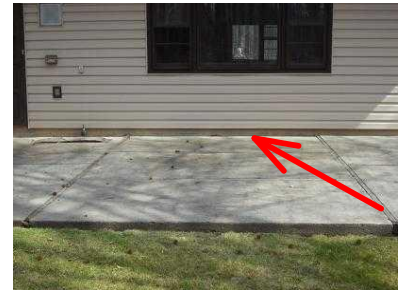
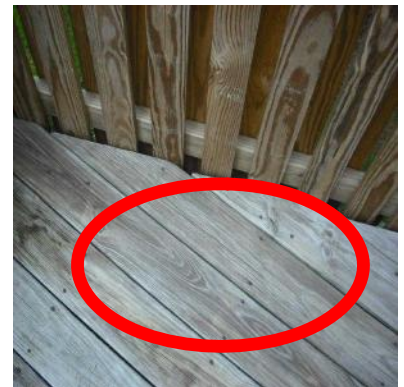
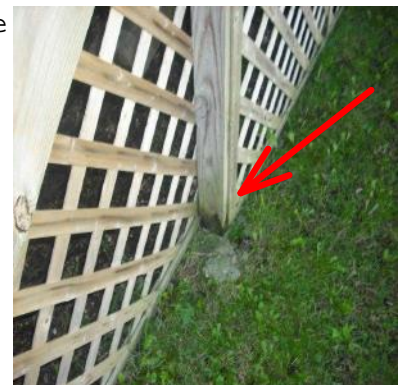
1. **Walks:** (Standard concrete slabs) Sidewalk damaged, repair as necessary
2. **Patio:** (Concrete) Negative slope - towards foundation, which brings rain water towards the foundation instead of away from the foundation (the patio appears to be sunk a couple of inches, repair as necessary)
3. **Deck:** (Wooden deck) general normal maintenance required, decks are susceptible to all weather conditions, regular routine maintenance required to assure safe functional condition (Note - there are a few loose boards and the deck needs sealer treatment, repair as necessary)
4. **Deck:** (Wooden deck) Support posts - are not set on concrete, the posts are wood to ground contact which rots wood and attracts termites

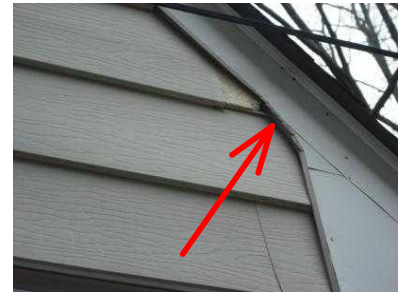
5. Trim/Fascia: (Wood) General maintenance required, maintain and repair when necessary, some wood rot noted, repair as necessary

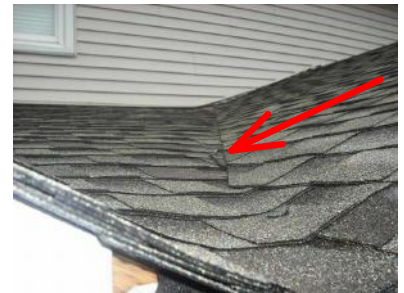
6. (Main roof) Roof Surface Material: (Asphalt Shingles) Shingles, deterioration/damage noted at the valley, the roof shingle is nearing the end of useful life. Recommend evaluation and repairs by licensed contractor before closing
7. Valleys: (Asphalt shingle) Valley shingles damaged, roof leak noted in this area, repair as necessary, recommend evaluation and repair by licensed contractor before closing

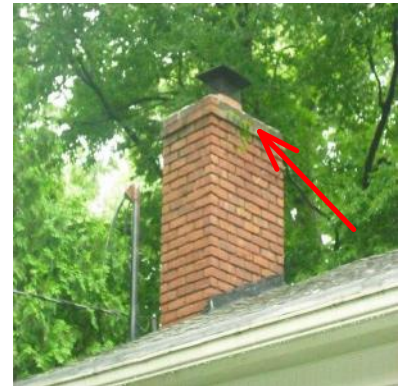
8. (Mid section of house roof) Chimney Chimney: (Brick and mortar) General pointing maintenance of chimney and flashing is required to avoid water problems. Damaged noted around the chimney cap, repair as necessary

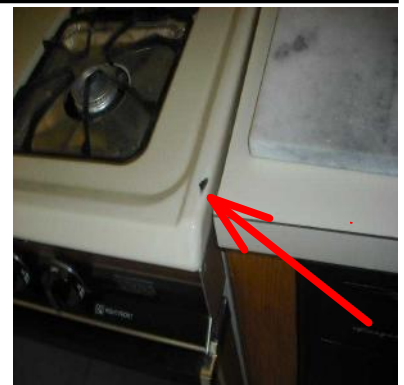
9. (First floor) Kitchen Stove/oven: (Standard stove/oven) Chip in stove burner area noted, repair as necessary, Also Noted, Door spring broken - The oven door spring appears to be broken, this is considered a safety hazard

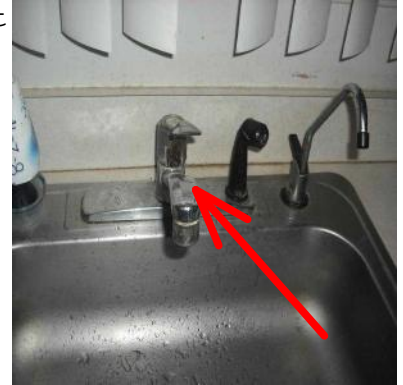
10. (First floor) Kitchen Plumbing/Fixtures: (Standard faucet/plumbing) Faucet is leaking, repair as necessary

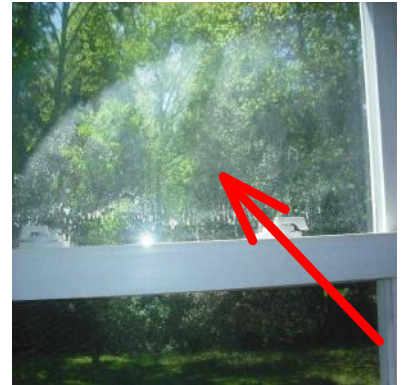
11. all rooms except kitchen and bathrooms Living Space Windows: thermopane General maintenance required, caulk, seal, free up and maintain and repair when necessary, Thermopane window damage noted in one or more thermopane windows there is moisture between the layers of glass, A qualified glazier is recommended to evaluate all windows and estimate repairs before closing

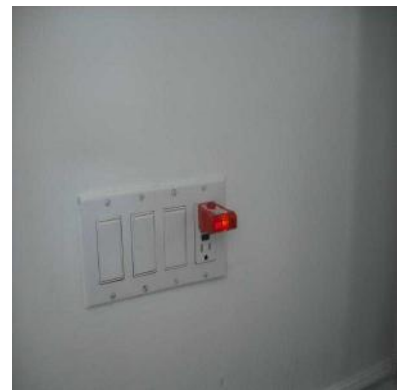
12. all rooms except kitchen and bathrooms Living Space Electrical: Electrical wiring) outlets - non grounded outlets noted, recommend evaluation and repair by licensed electrician before closing

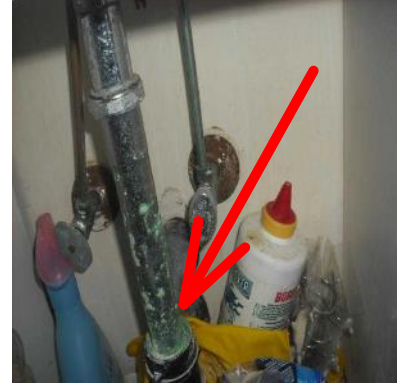
14. (Full Bath) Bathroom Faucets/Traps: (Standard faucets/plumbing) Drain line corrosion noted, repair as necessary

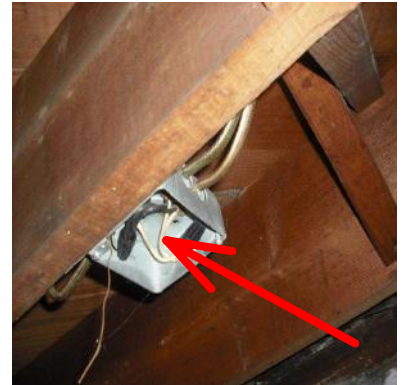
15. (Main house basement) Basement Bamt Walls: (Concrete block) damage noted, see structural section
16. (Main house basement) Basement Electrical: Electric wires) exposed wires and splices were found in various areas, A licensed electrician is recommended to evaluate and estimate repairs before closing

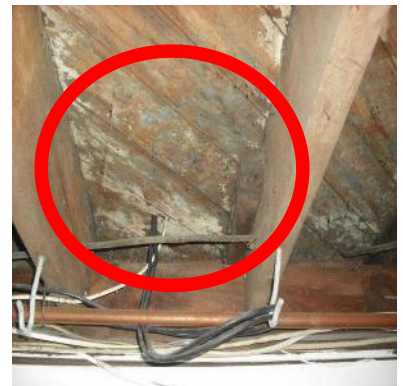
17. (Main house basement) Basement Moisture stains: (Moisture stains/discoloration noted) recommend a thorough moisture evaluation and repair by licensed contractor before closing
18. (Main house basement) Basement Informational Note: (Basement) Mold like substance noted, recommend a mold test before closing NOTE - mold is not included in a home inspection, any comments about mold like substance is courtesy only to protect the buyer, no liability will be accepted.

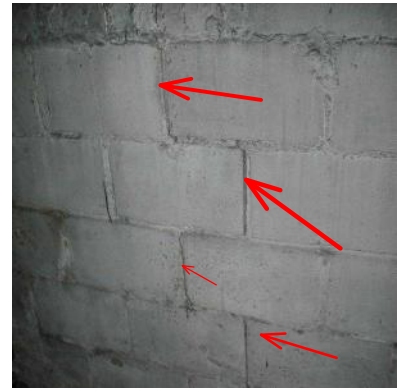
19. Foundation: (Concrete block/Slab floor) Cracks noted - cracks noted on foundation concrete block walls, repair as necessary, Recommend evaluation and repair by a licensed contractor before closing

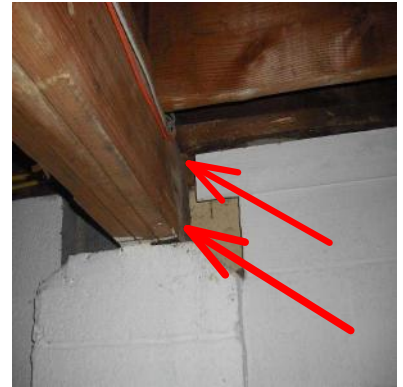
20. Beams: (Solid wood) some termite damage noted, see termite report)

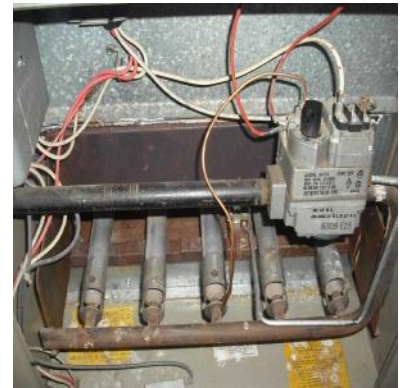
24. (Basement) Heating System Heating System Operation: (Functional needs service/maintenance) Dirt and rust in the burn chamber and unusual flame pattern, it appears that the unit has not been serviced in the last year as per manufactures service requirements. recommend evaluation and repair by licensed contractor before closing

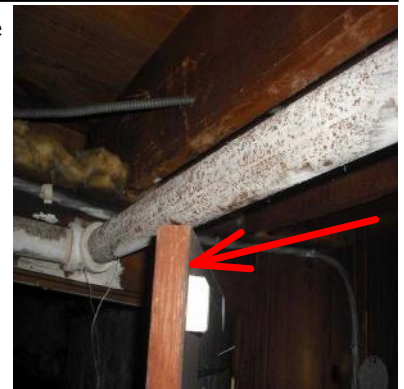
25. Drain Pipes: (Drain pipe) pipe is supported by board, should have pipe hanger, repair as necessary

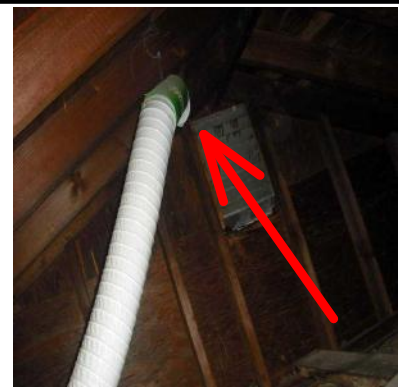
27. main house section Attic Bathroom Fan Venting: (Improper vent discharge) Fan vent terminates in the attic, this is a environmental safety hazard, repair as necessary

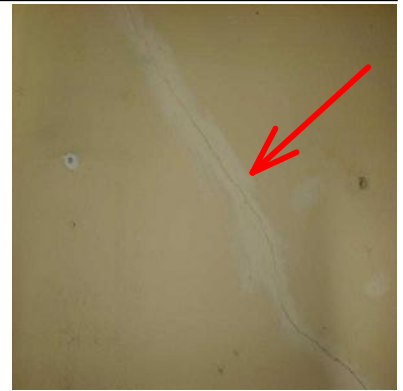
3. **Detached Garage Garage walls:** (Drywall) normal general maintenance required, fill common cracks, maintain and repair when necessary

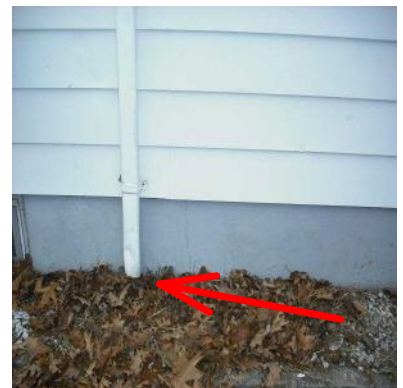
5. **Detached Garage Gutters/Downspouts:** (Same as house) Downspouts - extensions needed to direct water at least four feet away from the foundation

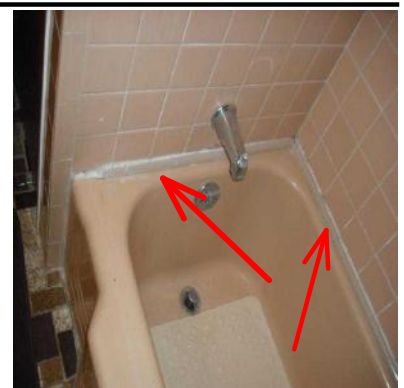
11. (Full Bath) Bathroom Tub/Surround: (Tub/ceramic tile surround) Caulking maintenance - replace caulking and sealer at tub surround to avoid water penetration behind the tiles

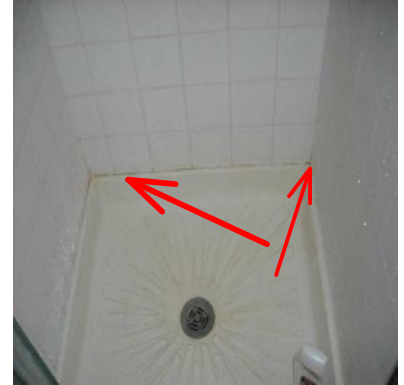
12. (Master bath) Bathroom Shower/Surround: (Pan/ceramic tile surround)
Normal caulking sealer maintenance required on walls and floor pan to avoid leaks and wall damage. No liability will be accepted for any hidden wall damage that may develop behind finished surfaces.

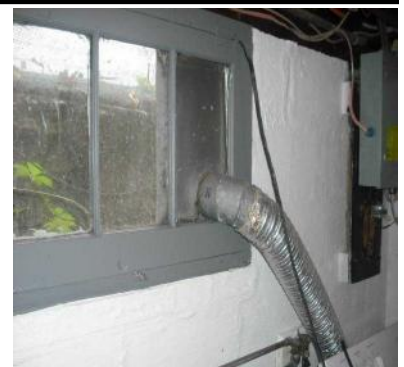
19. Basement Laundry Room/Area Vent/dryer: (Plastic flex) Plastic vent noted, recommend update to metal dryer vent for safety and also recommend complete cleaning of dryer vent before using. Note - manufacture recommends periodic cleaning of dryer vent to avoid fire hazards, Also noted, Plastic vent, through window, not a proper vent discharge through a window, repair as necessary

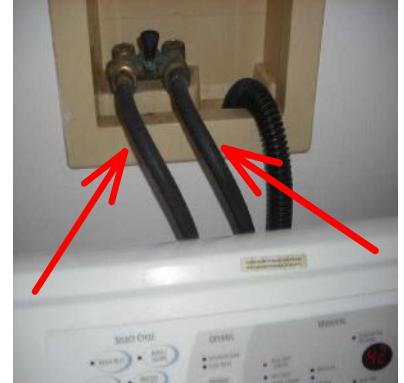
20. **Basement Laundry Room/Area Washer Hoses:** (Rubber Hoses) Rubber hoses noted, recommend update of hoses to metal braided hoses for safety, Over time rubber hoses have been known to leak and cause water damage, metal braided hoses appear to be more reliable.

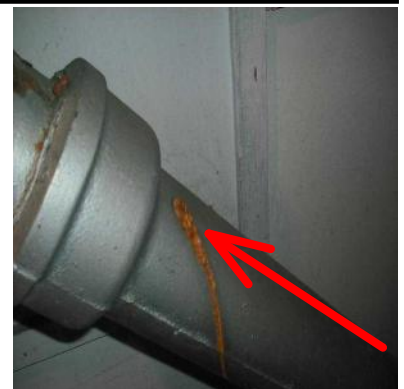
23. **Drain Pipes:** (Mixed, cast iron and galvanized) note - cast iron pipes are rusted and can develop leaks, no liability will be accepted for cast iron pipes that develop leaks after the inspection or leaks that are hidden from view)) (Cast iron), pin hole leak noted, repair as necessary, sewer drain line is about 60 years old, recommend a sewer line camera inspection before closing

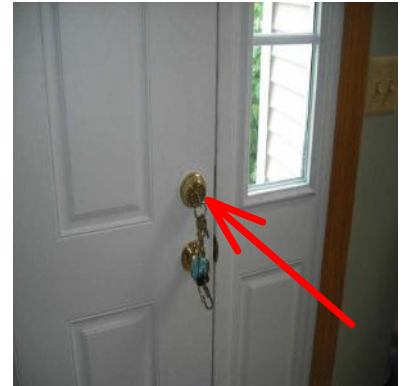
1. Front door entry: (Exterior door, Conventional) keyed dead bolt on the interior side of the door is a real safety hazard. In the event of a fire the door may be locked and the key cannot be found. Recommend removal of this type lock before closing

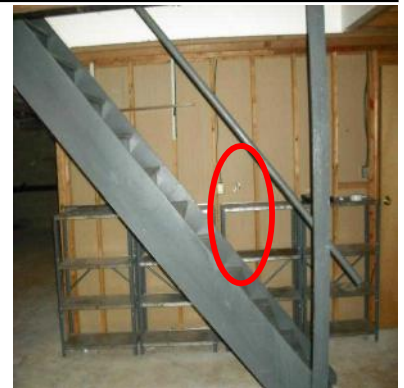
2. (Main house basement) Basement Stairs/Railings: (Stairs/hand rail) Open space on side of basement stairs is a safety hazard, A person or child could fall off the stairs to basement floor, recommend some type of safety balusters be installed.

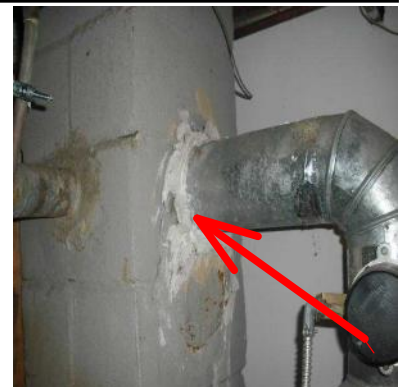
3. (Basement) Heating System Flue Pipe: (Metal flue pipe) Sealer maintenance needed where flue pipe goes into chimney
